# Case History: Application of Concrete Mat “TACOM Mat”

Project Title	Environmental Improvement of Shing Mun River – Stage 2
Construction Period	February 2005 – May 2005 (Concrete Mat Installation Period)
Client	Civil Engineering and Development Department
Main Contractor	China Harbour Engineering Company (Group)
Material Supplier	G and E Company Limited.
Product Quantity	1,800 m <sup>2</sup> of TACOM Mat Style Standard Type 150H

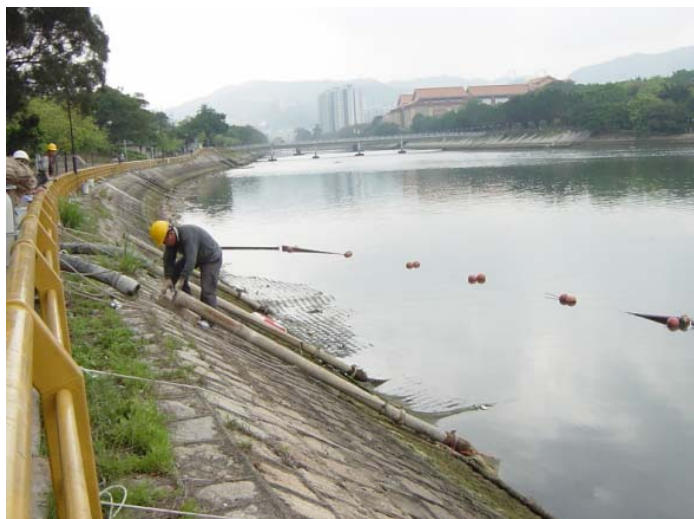
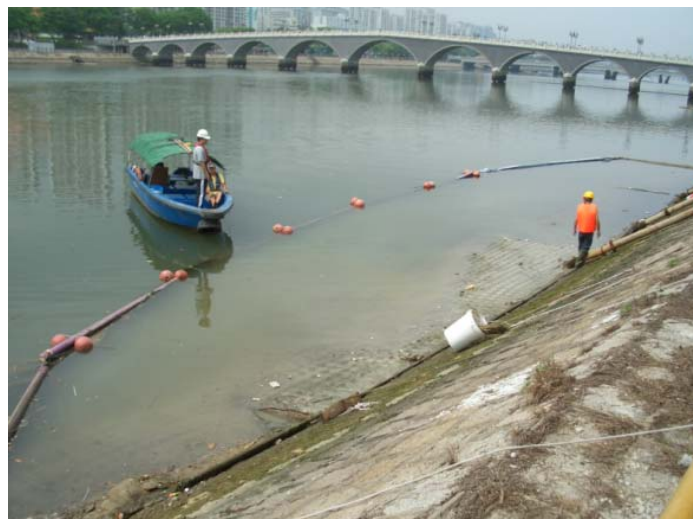
The system was custom fabricated into panel of 20 m x 3 m according to shop drawings worked out from survey data to fit actual site topography. A uniform 150 mm thickness and shrinkage were properly controlled. Special seams and

diaphragms were factory made to match concreting pressure. Four grouting inlets were prepared for each panel to ensure full grouting. The concrete lining on the northern side is about 280 m long while that on the south is about 320 m long, a total of 25 panels were supplied.

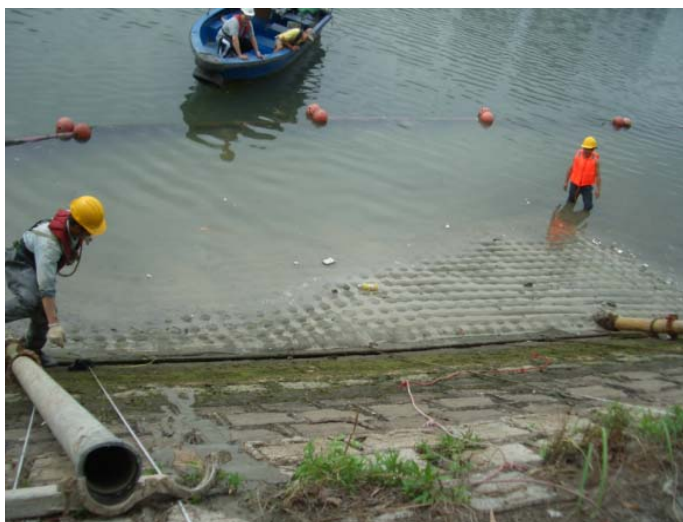
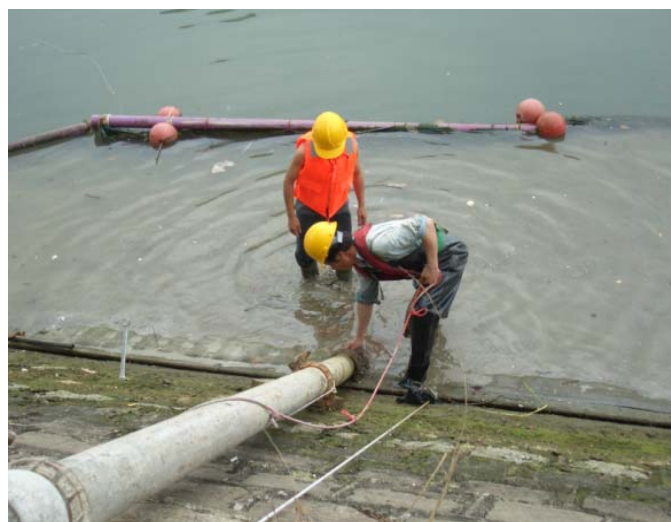
The installation of TACOM MAT is relatively straight forward. Each panel was placed at their location with the upper edge straightened by a bar which is tightened to anchor. The whole panel was temporarily positioned by using a bamboo stick. A special mix has been devised for grouting. Because of site constrain, concrete mix has to be delivered by Bobcat to a portable hopper/pump assembly. A series of pipes were deployed to inject grout through panel outlets. The technique was to fill up one compartment from bottom to top completely before moving to the next outlet. One panel must be completed on the same day. It is important to have TACOM Mat fully grouted. Panels were connected by tie wiring. Movement of the next panel must be allowed during grouting of the adjacent panel which often shrinks when it reached 150 mm thick. The difficulty lied in the lack of underwater visibility and the coordination of withdrawing pipe and grouting speed. In a number of occasions, extra concrete mix was needed to touch up on void space.
