Case History: Electrical Leak Location Survey

Project:	Inspiration Lake, Hong Kong Disney Land
Type of work:	Electrical Leak Location Survey
Location:	Penny's Bay, Hong Kong
Client:	Civil Engineering and Development Department
Consultant:	Maunsell Consultant Asia Ltd.
Main Contractor:	China State Construction Engg. Corp.
Survey Period:	March 2004

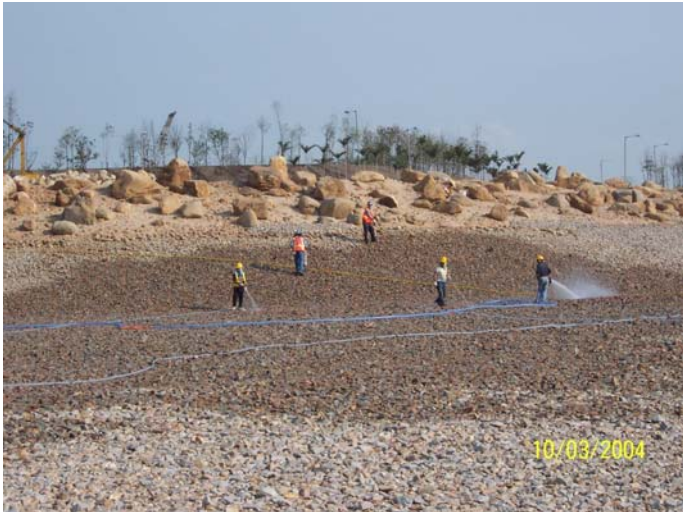
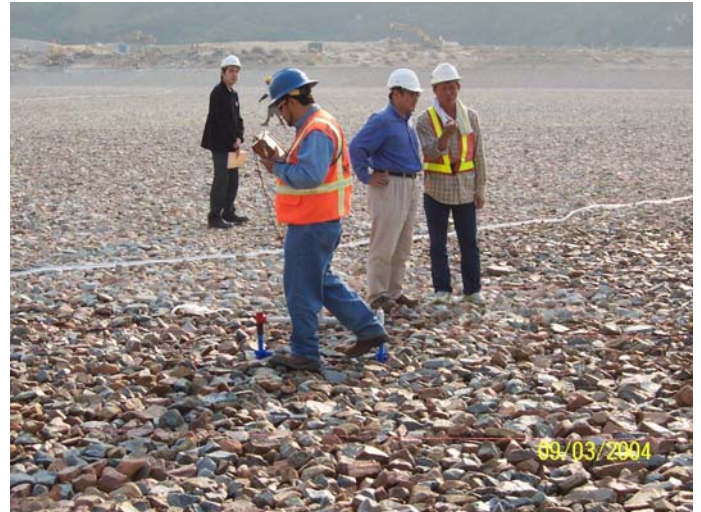
The survey method detects electrical paths through a geomembrane liner. A voltage is connected to one electrode placed in an electrically conductive material covering the geomembrane, and to a second electrode placed in electrical contact with material beneath the geomembrane. Electrical current flowing through holes in the geomembrane liner produces areas of high current density. These areas are located by making a series of systematic electrical potential measurement scans on or in the material covering the geomembrane.
